Acoustical leak detection survey of City of Orland  
Water Distribution System

## City of Orland Acoustic Leak Detection Survey

Report Prepared by  
Mark A. Carey, PE

MC Engineering, Inc.

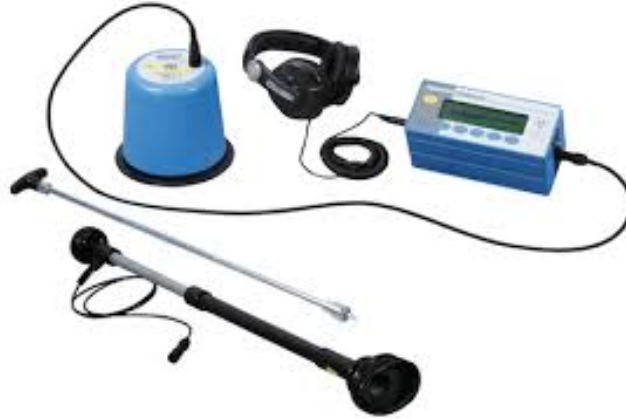
- 1) **HL 5000 Electroacoustic Water Leak Locator**

This equipment comes with various appurtenances including contact probes and a ground microphone. The HL 5000 is used to locate and listen to leaks in the field using either a contact probe at points of access (valves, meters, hydrants, etc.) or a ground microphone that is used on the surface.

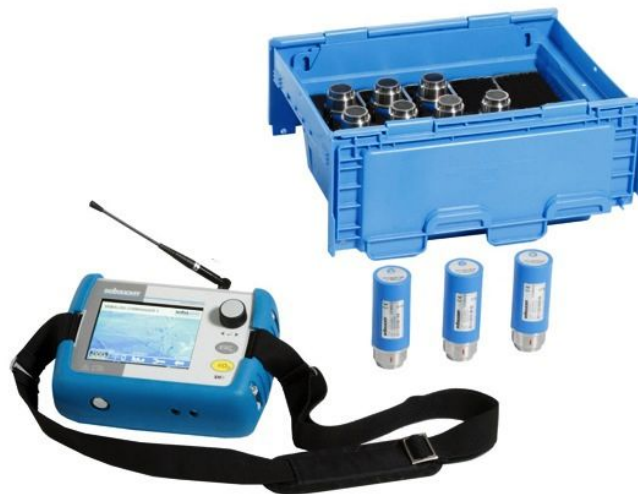
2) **Fifteen HL 7000 Noise loggers and associated Metrolog Commander:**

The noise loggers are deployed each day for subsequent listening and recording of sounds during quiet evening hours to minimize sound disturbances from normal water uses and/or surface noises.

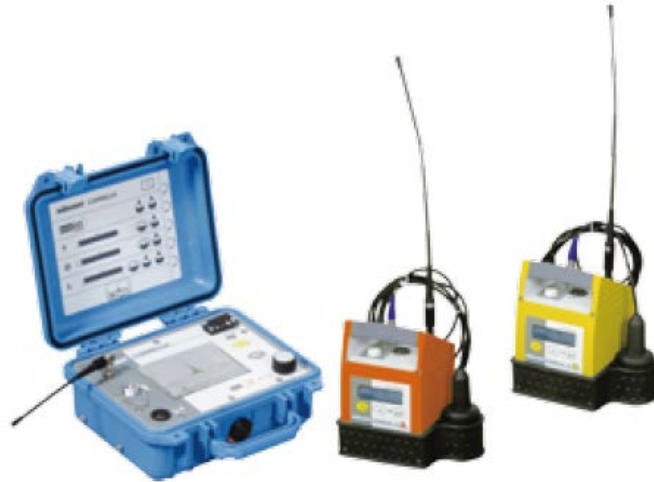
3) **Metrolog HL 6000 Correlator:**

The correlator is used to help pinpoint the location of suspected leaks by apply noise transmitting algorithms based on the speed of sound in different pipe materials.

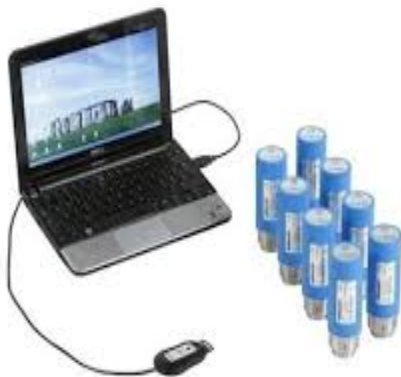
4) **Metrolog Correlating Loggers:**

The correlating loggers are deployed in groups of 3 to 4 devices around a point of suspected leakage. The loggers listen and record sound for subsequent analysis using a PC software program that compares the sound observed by each device in order to pinpoint source location/s. The correlating loggers are similar to the noise loggers in size and installation but include added features when coupled with PC software for pinpointing.

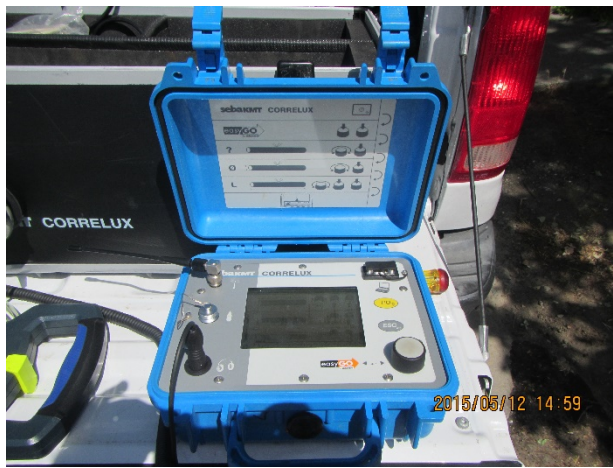
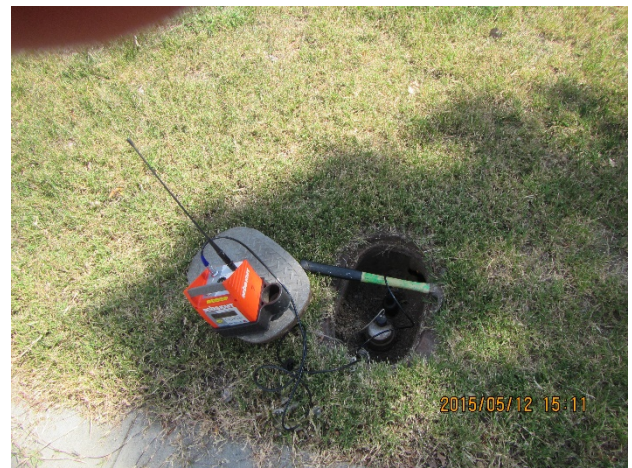
*Figure 3  
Correlator Setup*

Following the initial readings of the daily loggers, further investigation was performed. Contact microphones, ground microphone, and correlators were used in an effort to actively pinpoint the leaks. Figures 3 & 4 below show the setup of the correlators and the initial output. Areas that were targeted as potential leaks were marked in the streets and are shown in Figure 5.

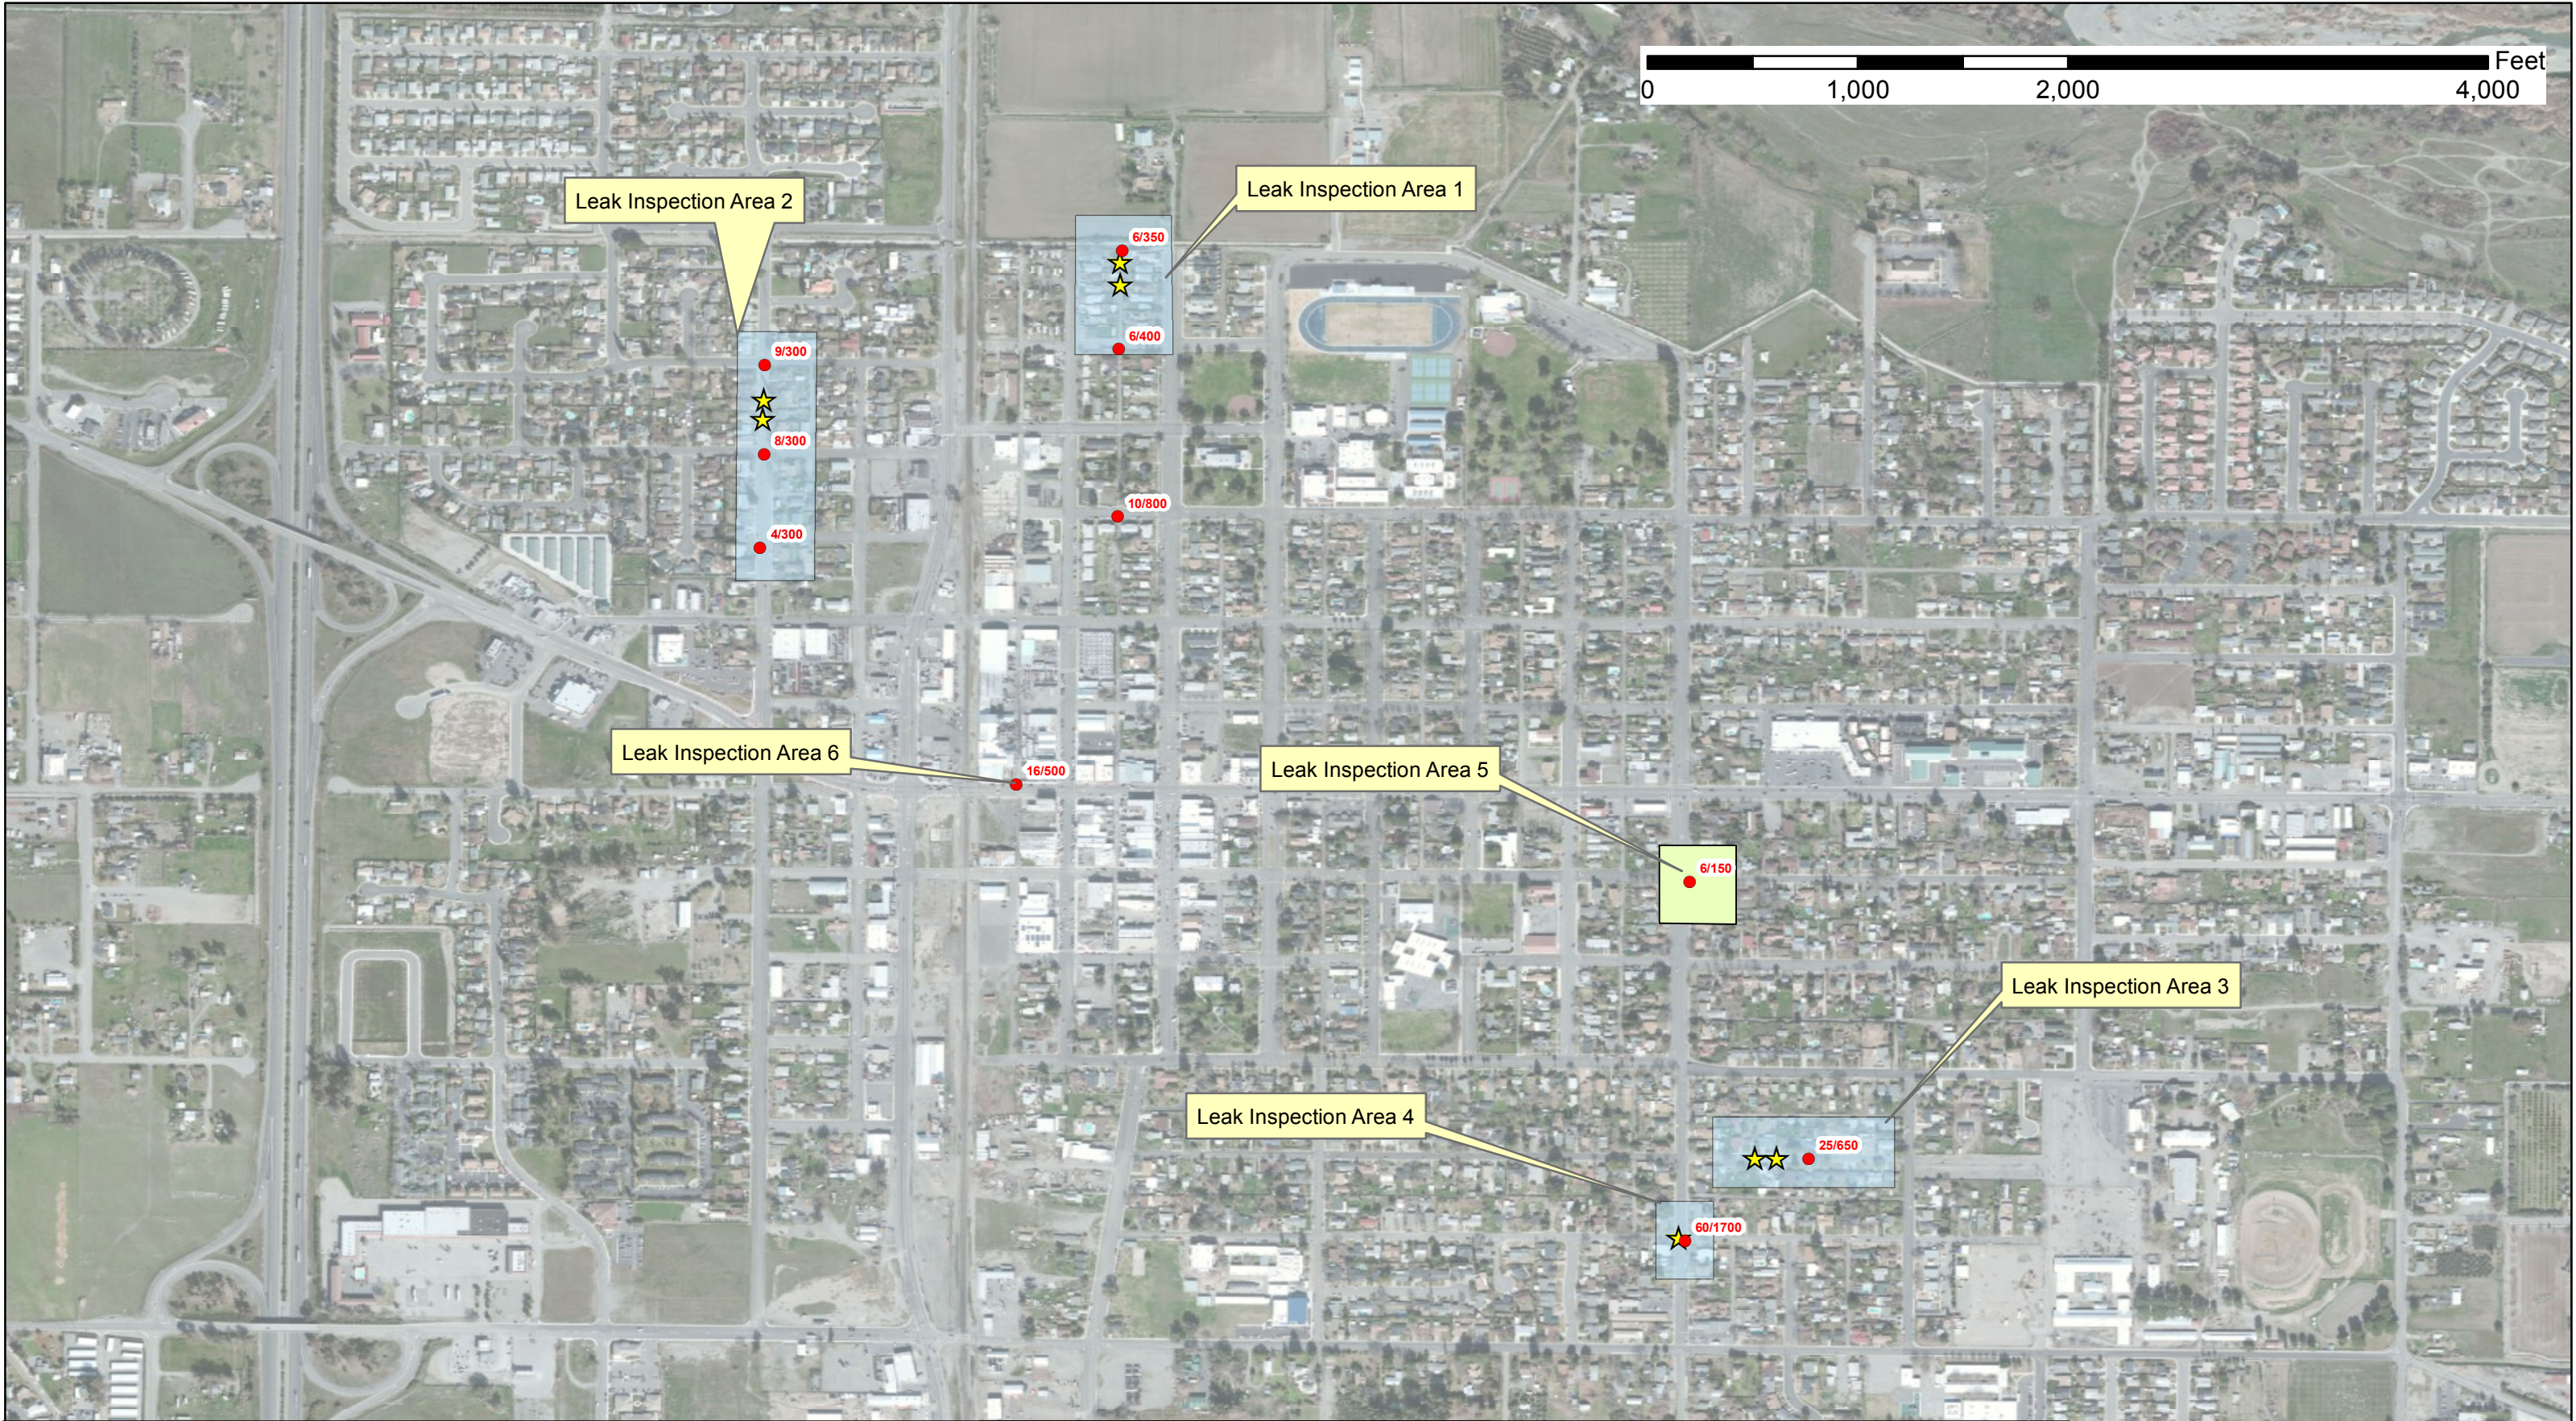
FIGURE 5 - POTENTIAL AND RESOLVED LEAK AREAS

A Suspected Leak Area Field Form for each of the leaks identified in Table 1 above are included in Appendix A. These field forms are intended to be used as a field guide when potential leaks are discovered. The field forms contained in Appendix A include a location description and maps of the suspected leak, initial readings and description of follow up equipment used to pinpoint the leaks, a more detailed remarks and follow up recommendation section, and a hyperlink to the audio file of the suspected leak. Figure 5 below shows the 4 areas of potential leaks along with the leak that was located and addressed by City staff.

LEAK LOCATED AND FIXED IN THE FIELD BY CITY STAFF

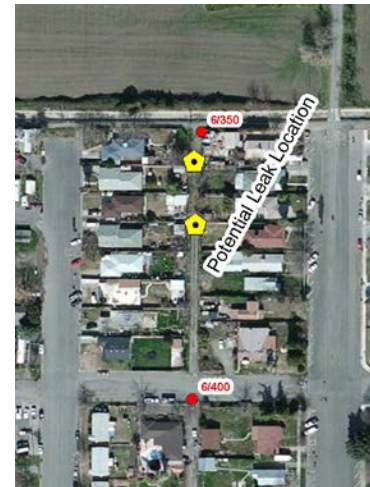
## LOCATION 1 - SUSPECTED LEAK AREA FIELD FORM – CITY OF ORLAND, CA

This area was confirmed to have more than 1 leak within the alley between 4<sup>th</sup> and 5<sup>th</sup> Street, between Suisun and Roosevelt Ave. Daily loggers, correlators and contact/ground microphones were used to confirm the leak location. It should be noted that there is the potential for multiple leaks in these areas. City staff confirmed that garbage trucks use the alleys and typically the water mains and services contain only 1-2' of cover. Further investigation into water mains that are located in alleys is suggested and pothole investigation in the area shown above is highly recommended.

| Suspected Leak Number | Suspected Leak Location | Approximate Address | Decibels/Hz | Approximated Leakage (gpm) | Notes and Follow-up Recommendations |
|---|---|---|---|---|---|
| <b>1</b> | In Mainline in alley behind house | 108 4 <sup>th</sup> Street | 6/350<br>6/400 | 10 | There are potentially multiple leaks in this area. Targeted potholing followed up with contact and ground microphone survey is recommended in this area |

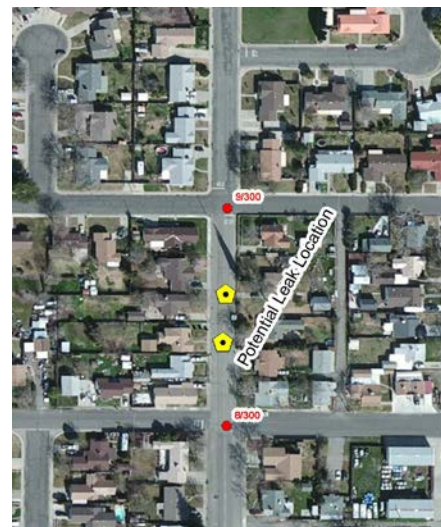
## LOCATION 2 - SUSPECTED LEAK AREA FIELD FORM – CITY OF ORLAND, CA

This area was confirmed to have more than 1 leak on 8<sup>th</sup> Street between Monterey and Trinity. Daily loggers were deployed and based on the decibel and Herz readings, it was decided that contact/ground mic analysis should be performed and also the deployment of the correlating loggers. The results of the correlators showed the possibility of 2 leaks. At this time, correlating loggers were deployed which also confirmed the leaks. It is recommended that potholing take place to pinpoint the leaks and fixes to the main line be implemented.

| Suspected Leak Number | Suspected Leak Location | Approximate Address | Decibels/Hz | Approximated Leakage (gpm) | Notes and Follow-up Recommendations |
|---|---|---|---|---|---|
| <b>2</b> | In Mainline in Street at 2 Locations | 218 8 <sup>th</sup> Street | 9/300<br>8/300<br>4/300 | 10 | Pothole in targeted area and deploy contact microphone and ground microphone to pinpoint leak/leaks |

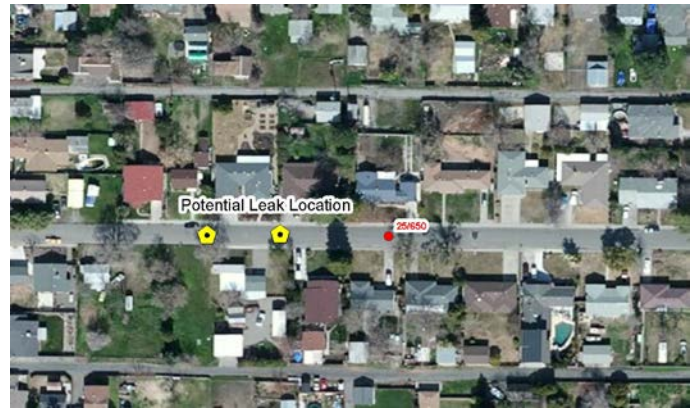
## LOCATION 3 - SUSPECTED LEAK AREA FIELD FORM – CITY OF ORLAND, CA

| <b>REMARKS:</b><br><br>This area was confirmed to have more than 1 leak on E. Central between East and Walnut. Daily loggers were deployed and based on the decibel and Herz readings, it was decided that contact/ground mic analysis should be performed and also the deployment of the correlators. The results of the correlators showed the possibility of 2 leaks. A It is recommended that potholing take place to pinpoint the leaks and fixes to the main line be implemented. | | | | | | | |

| Suspected Leak Number | Suspected Leak Location | Approximate Address | Decibels/Hz | Approximated Leakage (gpm) | Notes and Follow-up Recommendations |
|---|---|---|---|---|---|
| <b>3</b> | In Mainline in Street in 2 Locations | 36 E Central | 26/650 | 15 | Pothole in targeted area and deploy contact microphone and ground microphone to pinpoint leak/leaks |

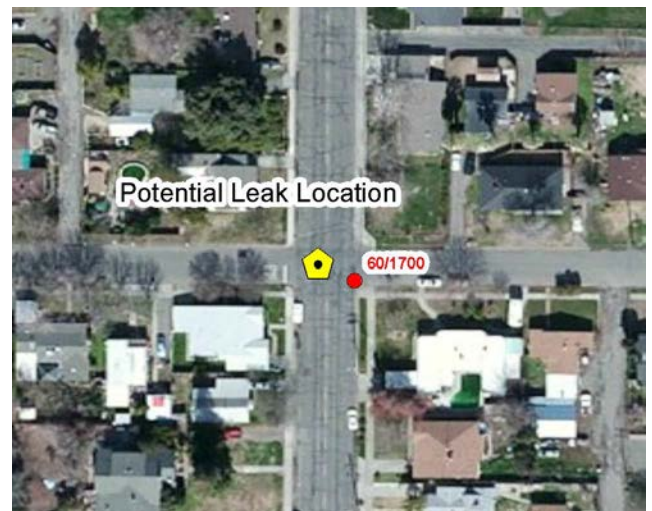
## LOCATION 4 - SUSPECTED LEAK AREA FIELD FORM – CITY OF ORLAND, CA

This area was first targeted for a potential leak when the daily loggers were being deployed. The valve box that was to be the location of the daily logger was 1/3 full of water, a sign that there was a leak in the vicinity. The daily logger received a definite potential for a leak. The correlating loggers were then deployed to pinpoint the leak and it was evident by the results of the correlating loggers that there was more than 1 hit in the intersection. It is recommended that the area be potholed. It is difficult to pinpoint the number of leaks along the main. This is due in part to the fact that there are not accurate records of how the mains and the valves are tied together. Further investigation is recommended.

| Suspected Leak Number | Suspected Leak Location | Approximate Address | Decibels/Hz | Approximated Leakage (gpm) | Notes and Follow-up Recommendations |
|---|---|---|---|---|---|
| <b>4</b> | Multiple leaks in Mainline in Intersection | 1130 East St. | 60/1700 | 10 | Pothole in targeted area and deploy contact microphone and ground microphone to pinpoint leak/leaks |

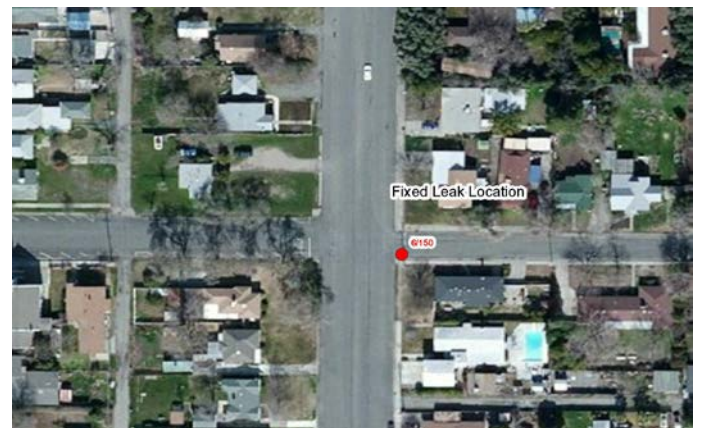
## LOCATION 5 - SUSPECTED LEAK AREA FIELD FORM – CITY OF ORLAND, CA

This area received a moderate hit on the daily loggers. It was deemed a suspect area and therefore an investigation with the contact microphone was under taken. While opening a valve box, it was discovered that it was full of water and it was also evident that the water was running into the storm drain. City staff was contacted and the water was removed from the valve box. A valve exercise was performed and it seemed to fix the leaking water. Placing a daily logger at the same location was verification that was was no mainline leak.

| Suspected Leak Number | Suspected Leak Location | Approximate Address | Decibels/Hz | Approximated Leakage (gpm) | Notes and Follow-up Recommendations |
|---|---|---|---|---|---|
| <b>5</b> | Leak in Valve box in sidewalk | 731 East Street | 6/150 | 1.5 | This was a visual leak discovery and the City staff was contacted and the leak was fixed |

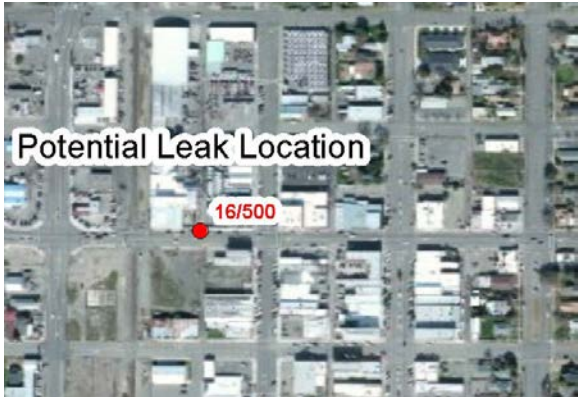
| LOCATION 6 - SUSPECTED LEAK AREA FIELD FORM – CITY OF ORLAND, CA | | | | | |
|---|---|---|---|---|---|
| <b>REMARKS:</b><br><br>This area was surveyed using the daily loggers. The loggers were deployed for 2 days and each day there was evidence of a leak. Correlation and pinpointing was not possible for this location due to high traffic and safety concerns. It is recommended that further investigation take place using correlators and contact/ground microphones and possible potholing. | | | | | |

| Suspected Leak Number | Suspected Leak Location | Approximate Address | Decibels/Hz | Approximated Leakage (gpm) | Notes and Follow-up Recommendations |
|---|---|---|---|---|---|
| <b>6</b> | Possible Leaks in Mainline | 731 East Street | 16/500<br>15/550 | 10 | Due to the traffic and inaccessibility of the area on Highway 32, no correlating took place. It is recommended that further analysis be done, possibly with a street shutoff |
